# FULL RESERVE STUDY

## The Sandarac Association, Inc.

**Fort Myers Beach, Florida**  
**February 11, 2019**

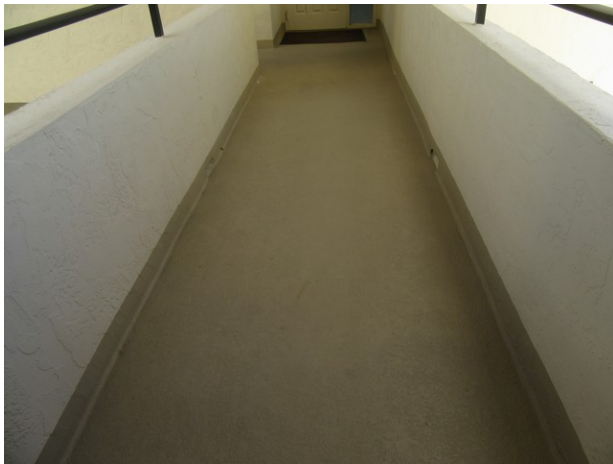
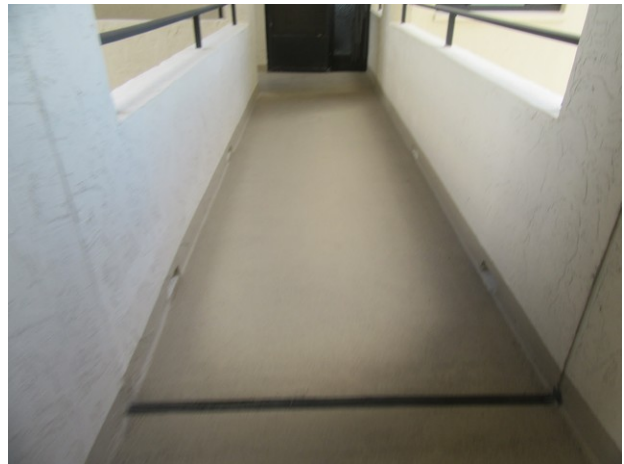
**History:** Previous repairs evident; coating applications conducted in 2013

**Condition:** Good to fair overall

**Breezeway with waterproof coating**

**Useful Life:** Capital repairs including a close-up visual inspection, patching of delaminated concrete, routing and filling of cracked concrete, and waterproof coating applications every 8- to 12-years.

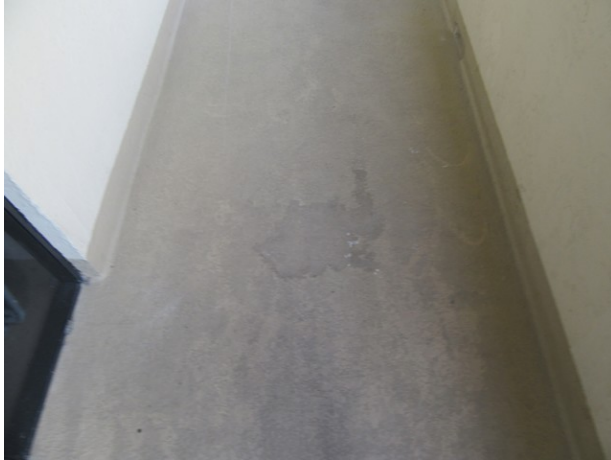
**Waterproof coating deterioration**

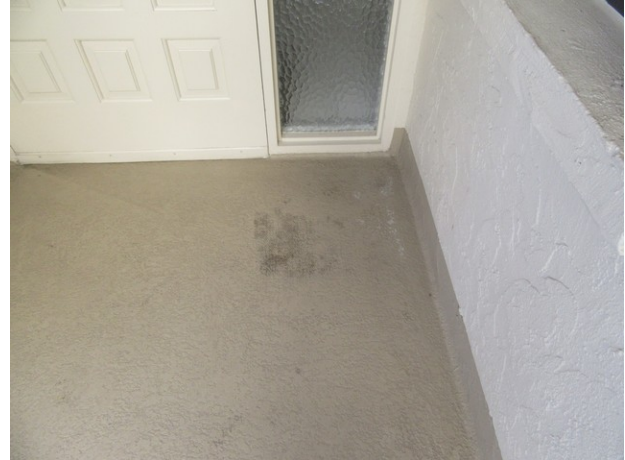
**Waterproof coating deterioration**

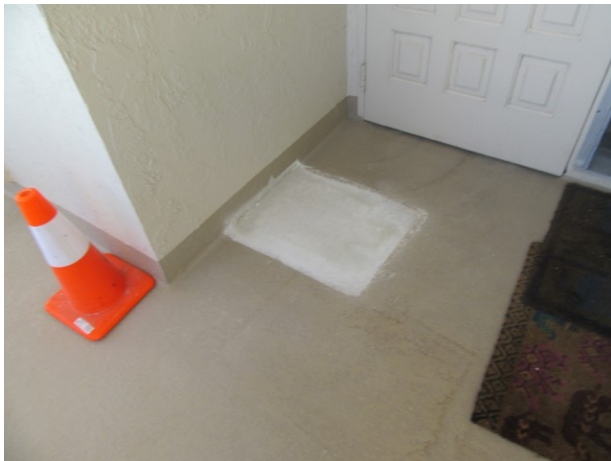
**Concrete repair at Unit A 810 entrance**

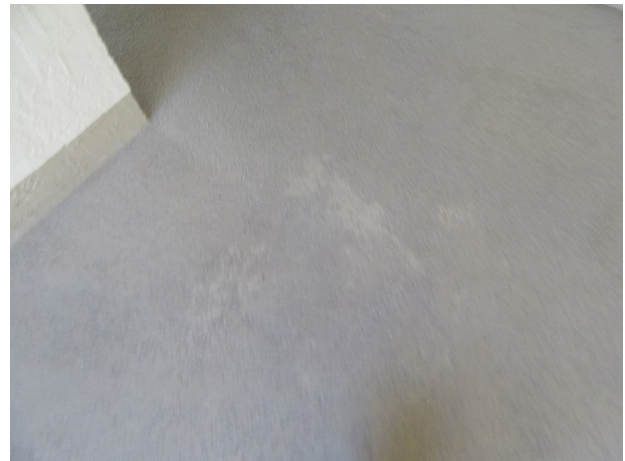
**Waterproof coating deterioration**

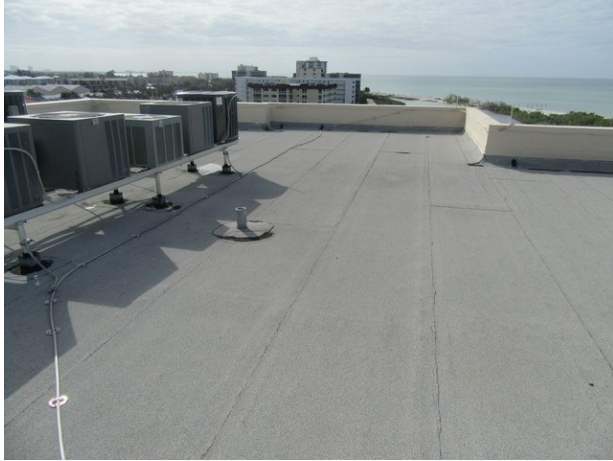
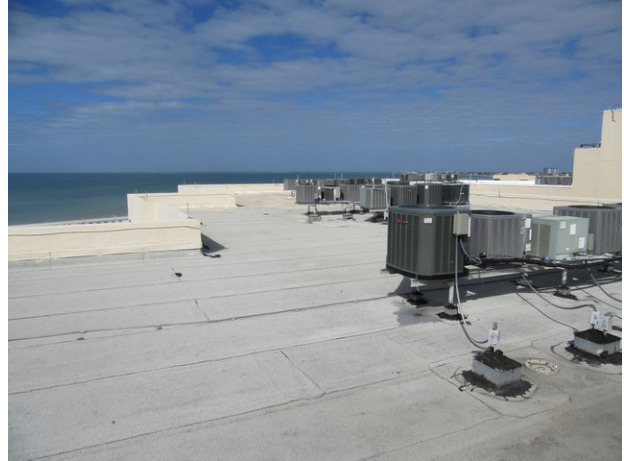
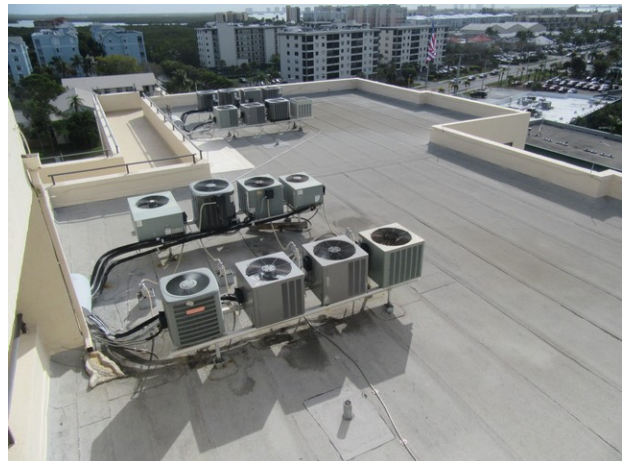
**History:** The roofs were installed between 2002 and 2003

**Condition:** Fair overall

**Modified bitumen roof**

**Modified bitumen roof (roof stack 6 with coating on right)**

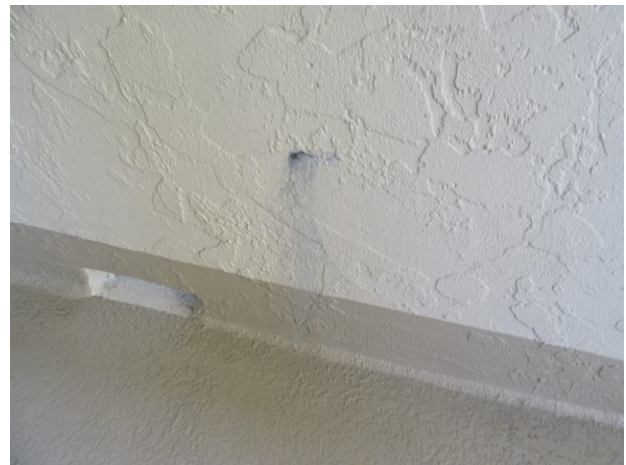
**Condition:** Good to fair overall with isolated finish deterioration

**Isolated paint finish deterioration**

**Useful Life:** We recommend inspections, repairs and paint finish applications every six- to eight-years.

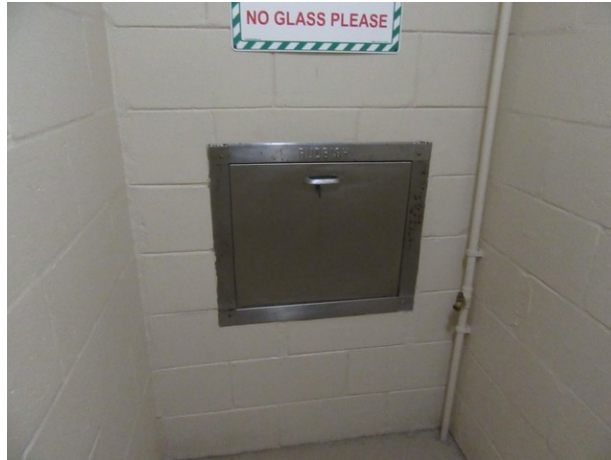
**Condition:** Reported fair overall

**Trash chute door**

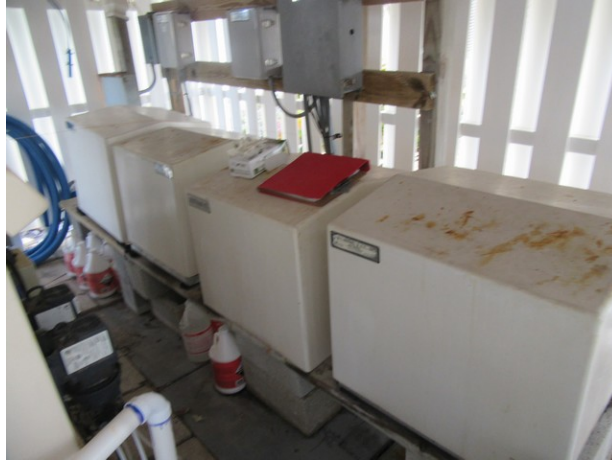
**Condition:** Management informs us the heaters will require near term replacement

**Geothermal heaters**

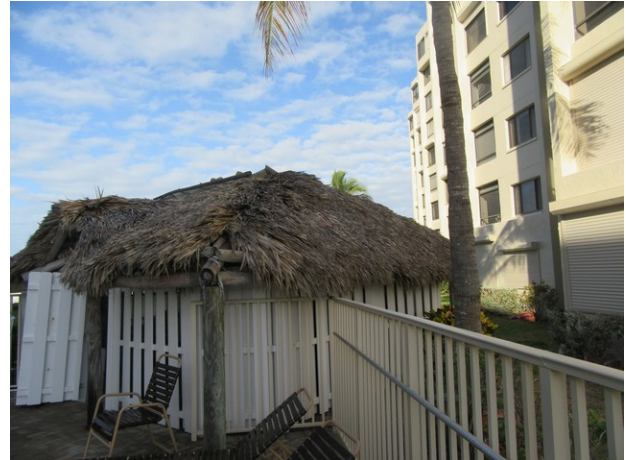
**Tiki hut thatched roof**

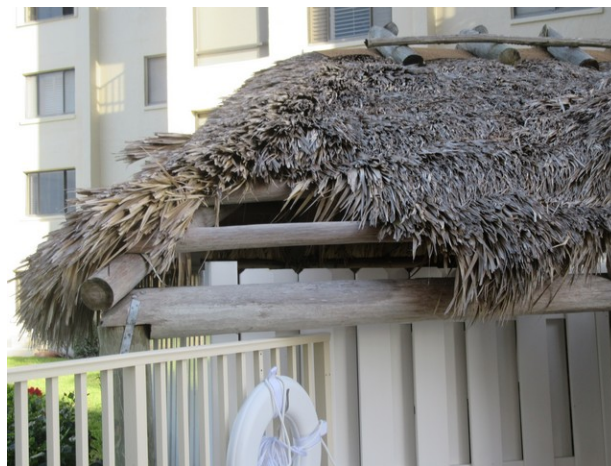
**Condition:** Fair overall

**Missing thatched roof**
