COMMERCIAL WINDSTORM MITIGATION REPORT

The Sandarac

Prepared Exclusively for The Sandarac Association, Inc.

As of 6/24/2020

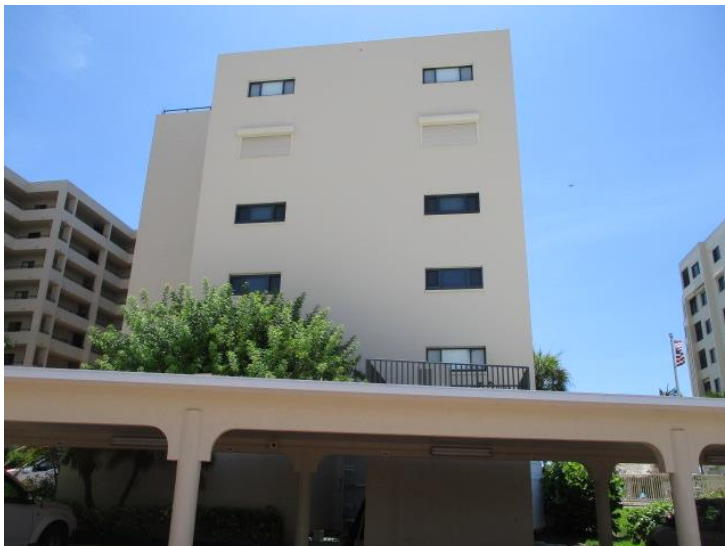
Exterior Elevation

- 7. Opening Protection:** **None or Some Glazed Openings**
Comments: Inspection verified some metal shutter and some impact rated windows. Not all glazed openings were protected with impact resistant coverings.

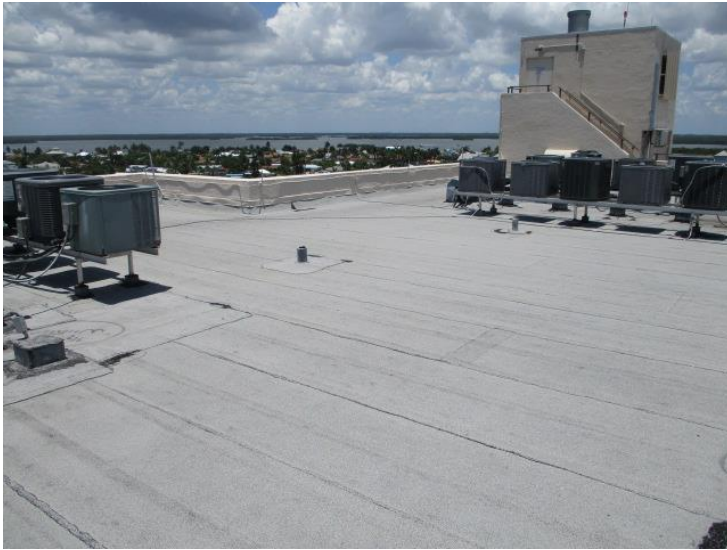
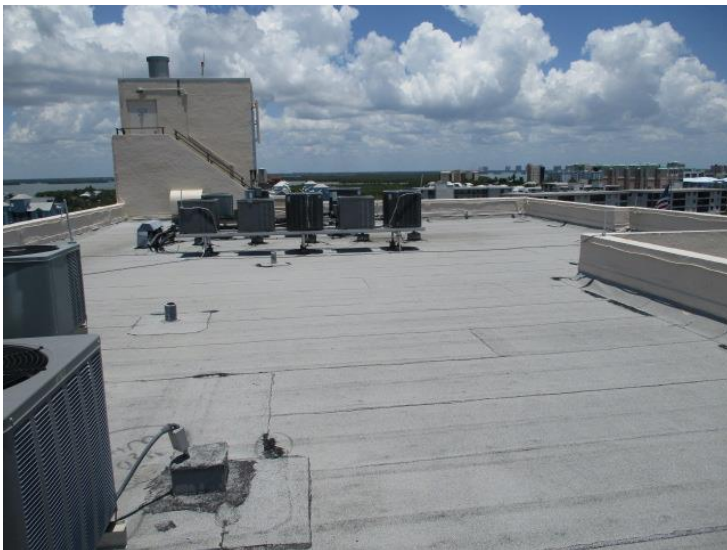
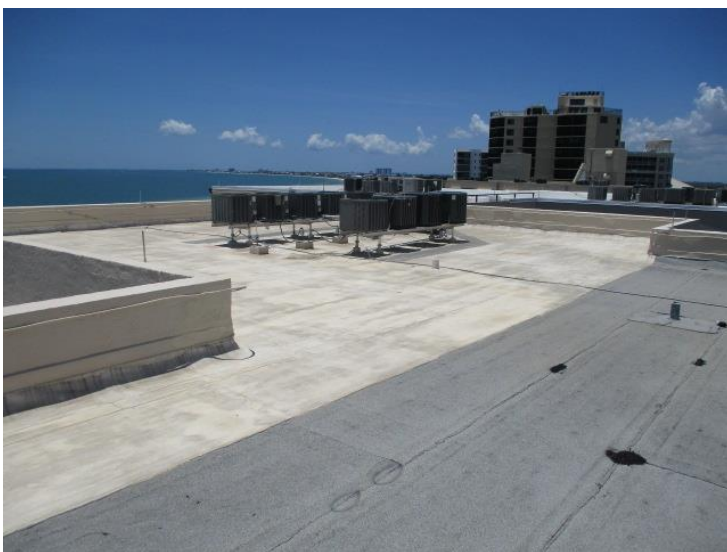
Roof Construction

- 2. Roof Covering:** **One or more roof coverings do not meet the minimum requirements**
Comments: The flat roof covering was replaced in 2000-2002. The roof permit was confirmed and the permit numbers are ROF2000-02086, ROF2002-02308. A section of this roof was re-coated in 2019. This roof was verified as not meeting the building code requirements outlined on the mitigation affidavit.

- 3. Roof Deck Attachment:** **Reinforced Concrete Roof Deck**
Comments: Inspection verified a roof structure composed of cast-in-place or pre-cast structural concrete designed to be self-supporting and integrally attached to the wall / support system.

- 4. Roof to Wall Attachment:** **Structural**
Comments: Inspection verified a roof structure composed of cast-in-place or pre-cast structural concrete designed to be self-supporting and integrally attached to the wall / support system.

- 5. Roof Geometry:** **Flat Roof**
Comments: Inspection verified flat roof shape, refer to attached photographs.
- 6. SWR:** **No**
Comments: No SWR verified.

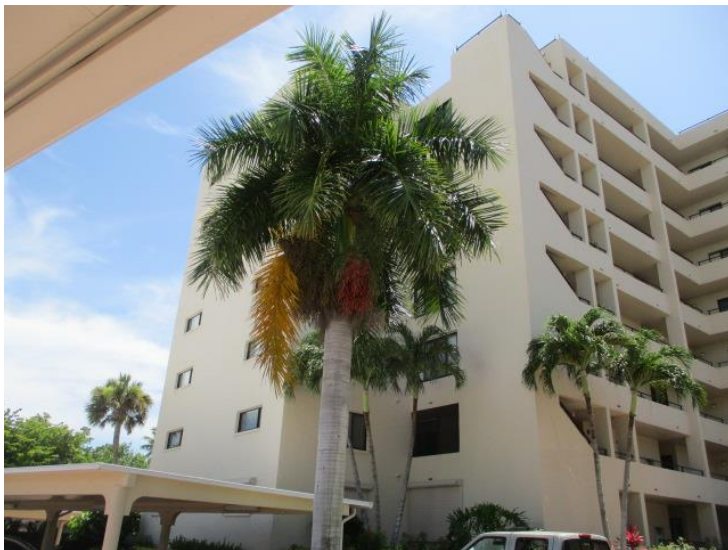
Exterior Elevation

7. **Opening Protection:** **None or Some Glazed Openings**
Comments: Inspection verified some metal shutter and some impact rated windows. Not all glazed openings were protected with impact resistant coverings.

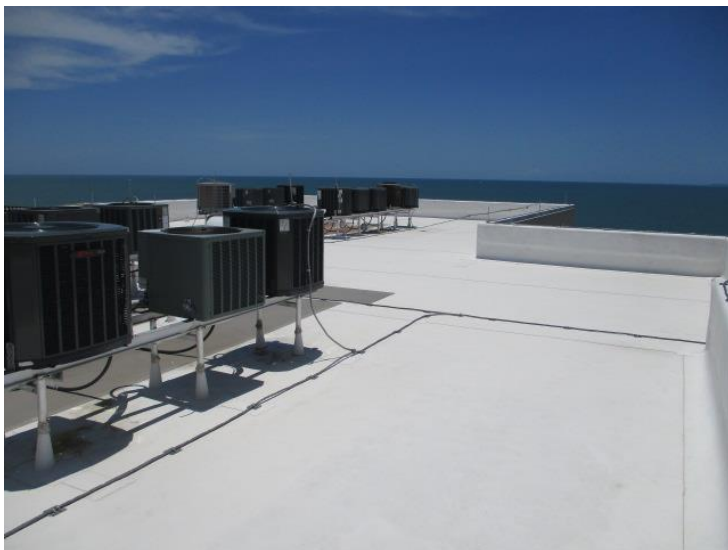
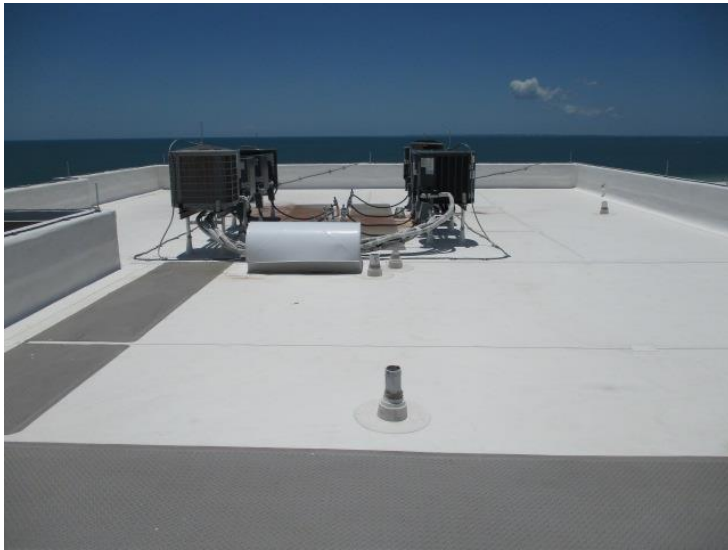
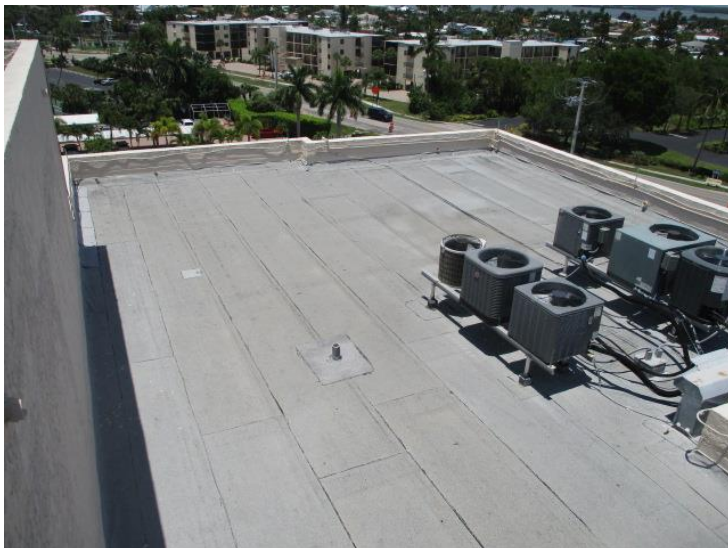
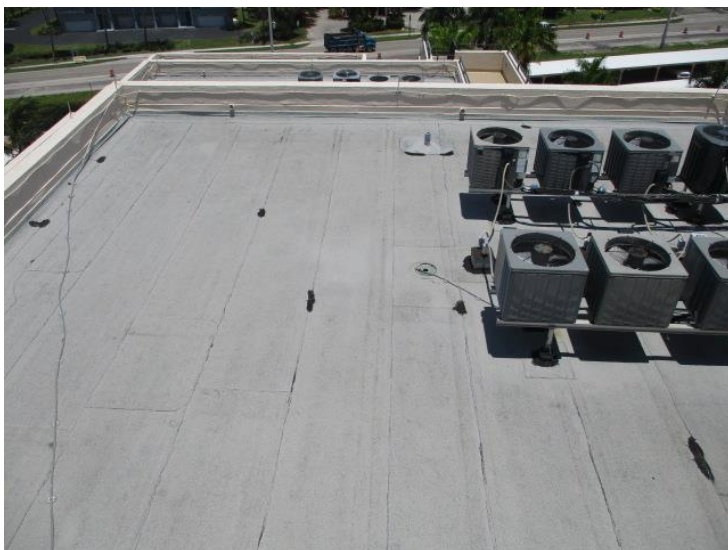
Roof Construction

2. **Roof Covering:** **One or more roof coverings do not meet the minimum requirements**
Comments: The flat roof covering was replaced in 2000-2002. The roof permit was confirmed and the permit numbers are ROF2000-02292, ROF2002-02307. A section of this roof was re-coated in 2019. This roof was verified as not meeting the building code requirements outlined on the mitigation affidavit.

5. **Roof Geometry:** **Flat Roof**
Comments: Inspection verified flat roof shape, refer to attached photographs.
6. **SWR:** **No**
Comments: No SWR verified.

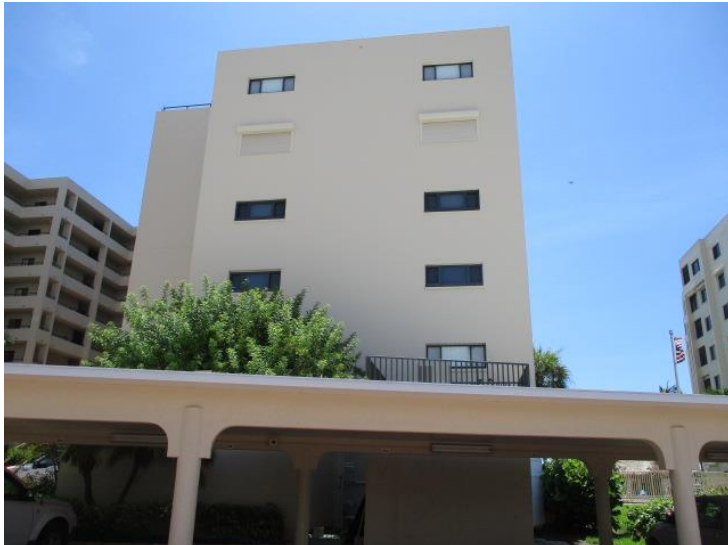
Exterior Elevation

- 1. Roof Covering:** **One or more roof coverings do not meet the minimum requirements**
Comments: The flat roof covering was replaced in 2000-2002. The roof permit was confirmed and the permit numbers are ROF2000-02086, ROF2002-02308. A section of this roof was re-coated in 2019. This roof was verified as not meeting the building code requirements outlined on the mitigation affidavit.
- 2. Roof Deck Attachment:** **Reinforced Concrete Roof Deck**
Comments: Inspection verified a roof structure composed of cast-in-place or pre-cast structural concrete designed to be self-supporting and integrally attached to the wall / support system.
- 3. SWR:** **No**
Comments: No SWR verified.
- 4. Opening Protection:** **None or Some Glazed Openings**
Comments: Inspection verified some metal shutter and some impact rated windows. Not all glazed openings were protected with impact resistant coverings.

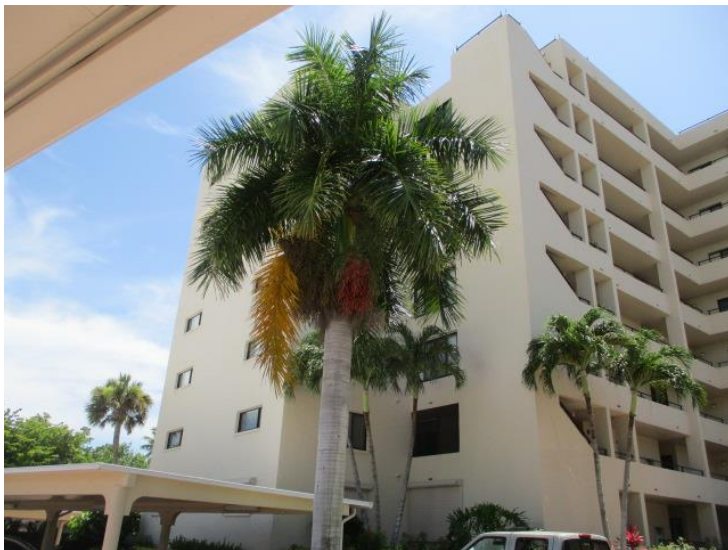
Exterior Elevation

- 1. Roof Covering:** **One or more roof coverings do not meet the minimum requirements**
Comments: The flat roof covering was replaced in 2000-2002. The roof permit was confirmed and the permit numbers are ROF2000-02292, ROF2002-02307. A section of this roof was re-coated in 2019. This roof was verified as not meeting the building code requirements outlined on the mitigation affidavit.
- 2. Roof Deck Attachment:** **Reinforced Concrete Roof Deck**
Comments: Inspection verified a roof structure composed of cast-in-place or pre-cast structural concrete designed to be self-supporting and integrally attached to the wall / support system.
- 3. SWR:** **No**
Comments: No SWR verified.
- 4. Opening Protection:** **None or Some Glazed Openings**
Comments: Inspection verified some metal shutter and some impact rated windows. Not all glazed openings were protected with impact resistant coverings.
