## COMMERCIAL WINDSTORM MITIGATION REPORT (OIR-B1-1802)

The Sandarac Association, Inc.

6670 Estero Blvd, Units 101-605, 701-704, 801-803, 901-902

As of 6/24/2020

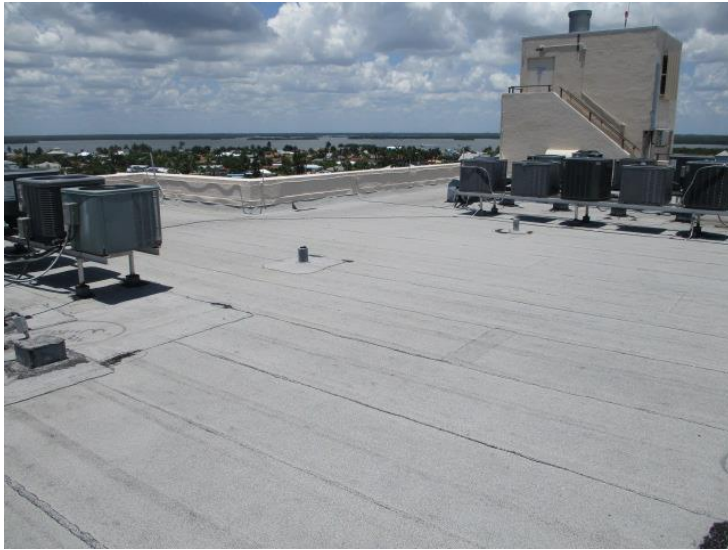
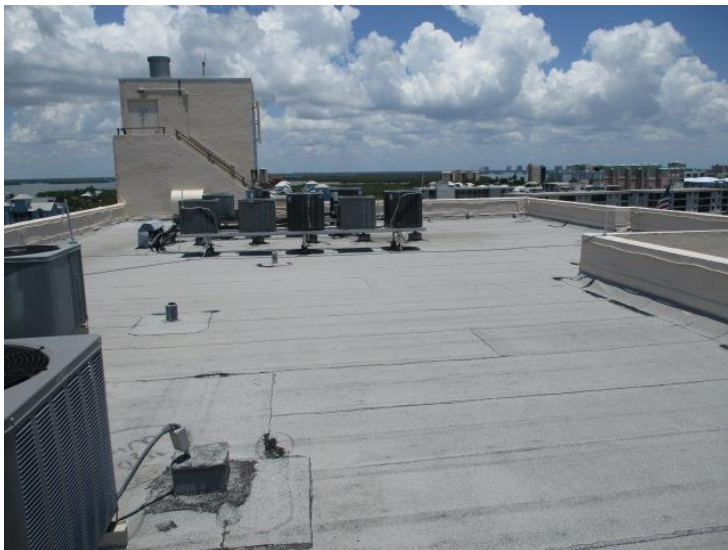
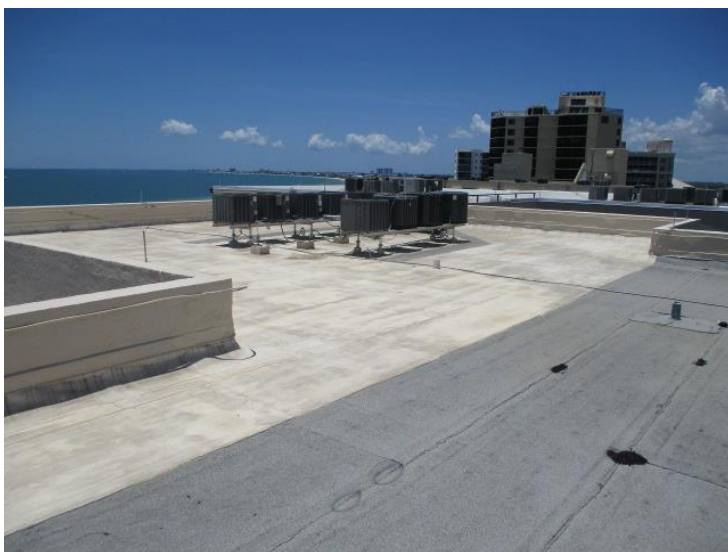
Roof Construction

- 3. Roof Deck Attachment:**        **Reinforced Concrete Roof Deck**  
Comments:                                      Inspection verified a roof structure composed of cast-in-place or pre-cast structural concrete designed to be self-supporting and integrally attached to the wall / support system.

- 4. Roof to Wall Attachment:**        **Structural**  
Comments:                                      Inspection verified a roof structure composed of cast-in-place or pre-cast structural concrete designed to be self-supporting and integrally attached to the wall / support system.

- 5. Roof Geometry:**                      **Flat Roof**  
Comments:                                      Inspection verified flat roof shape, refer to attached photographs.
