COMMERCIAL WINDSTORM MITIGATION REPORT (OIR-B1-1802)

The Sandarac Association, Inc.

6672 Estero Blvd, Units 106-711, 806-810, 906-908

As of 6/24/2020

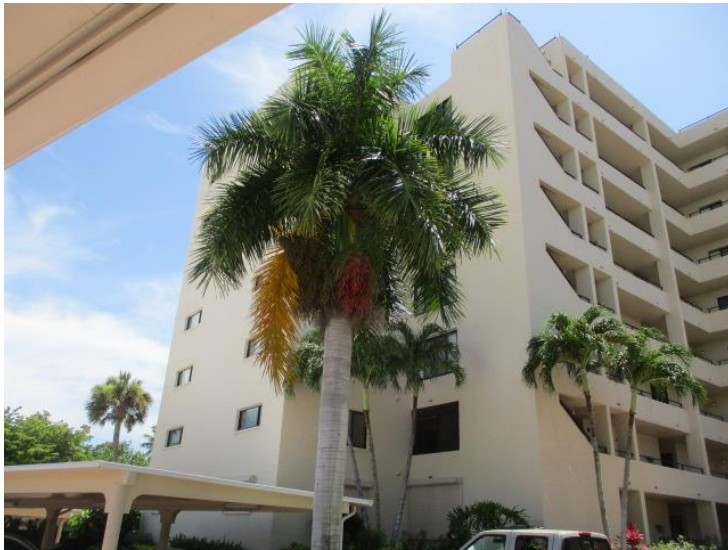
Exterior Elevation

5. **Roof Geometry:** **Flat Roof**
Comments: Inspection verified flat roof shape, refer to attached photographs.
6. **SWR:** **No**
Comments: No SWR verified.
