# FULL RESERVE STUDY

## The Sandarac Association, Inc.

**Fort Myers Beach, Florida**  
**February 11, 2019**

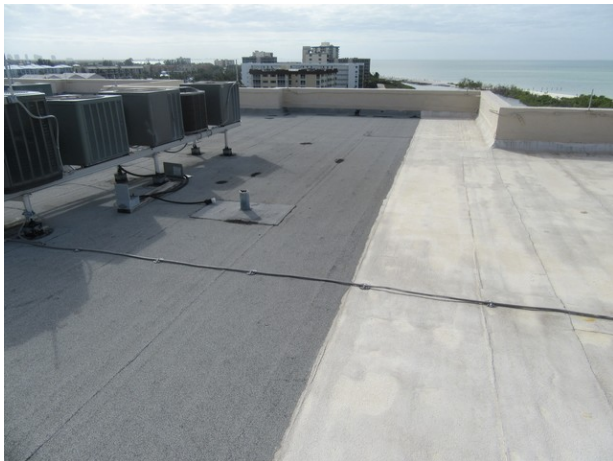
**Modified bitumen roof (roof stack 6 with coating on right)**

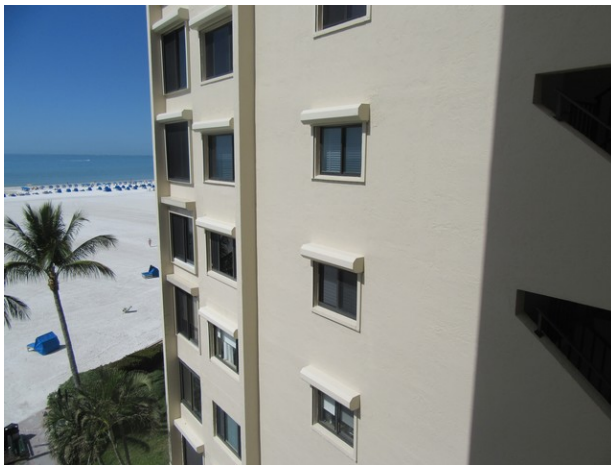
**Condition:** Good to fair overall with isolated finish deterioration

**Exterior stucco walls**

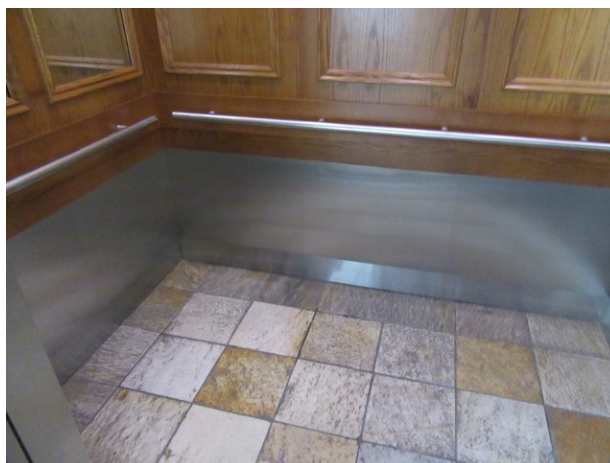
**Condition:** Good overall

**Elevator cab finishes**

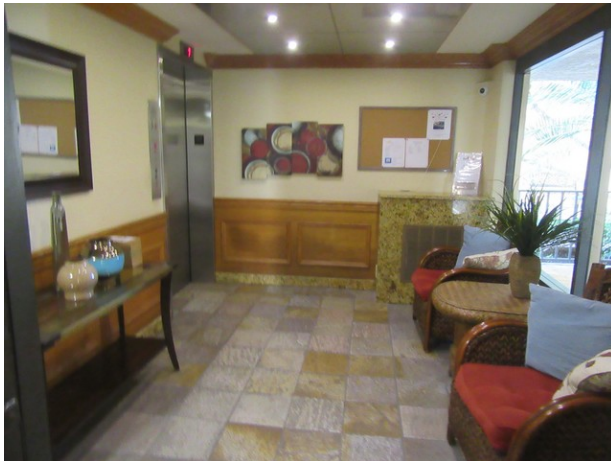
**Condition:** Good overall

**Tile floor coverings at lobby**

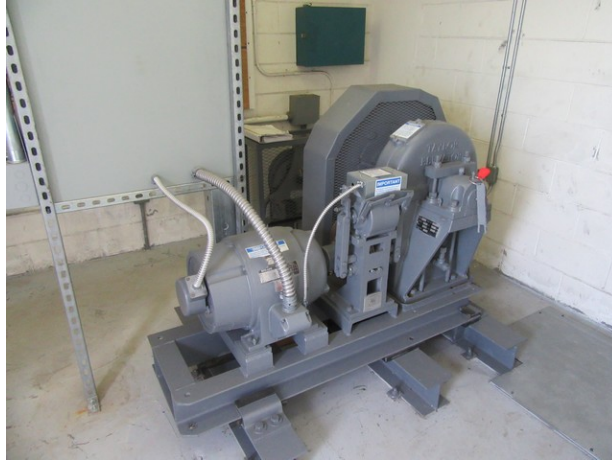
**Condition:** Reported satisfactory operational and service interruptions are reportedly infrequent.

**Elevator machine and hoist**

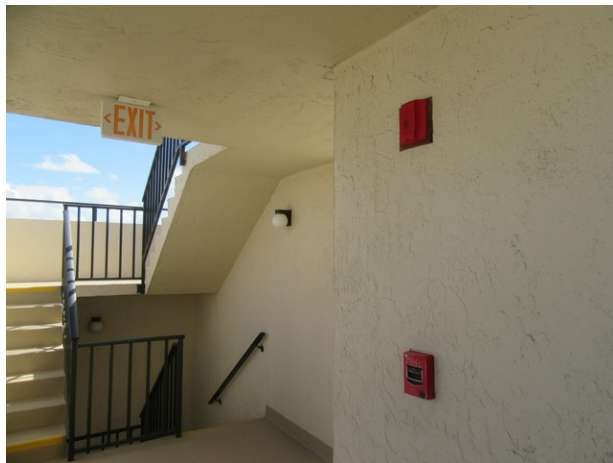
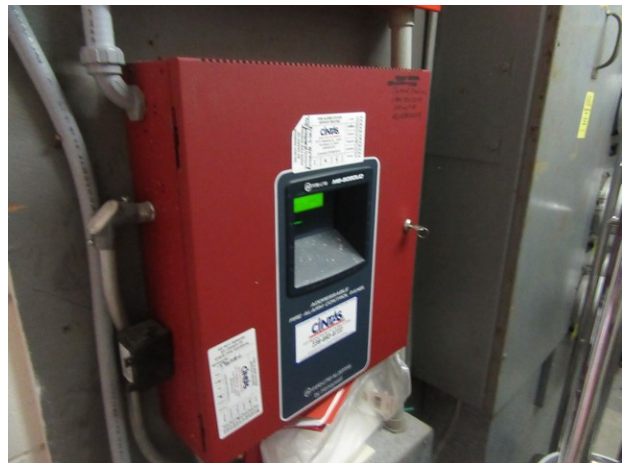
**Conditions:** Reported satisfactory operational

Life safety system components

Life safety system control panel

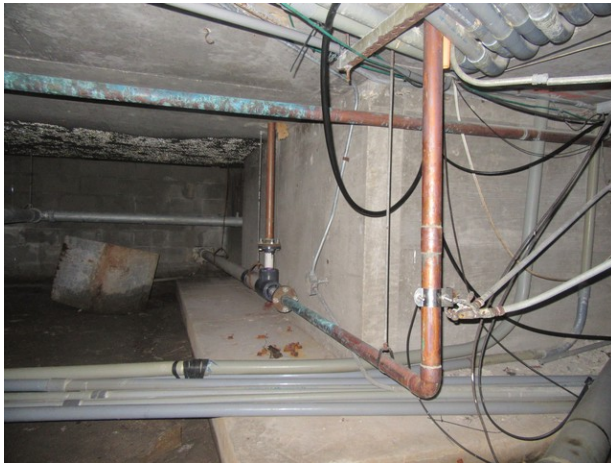
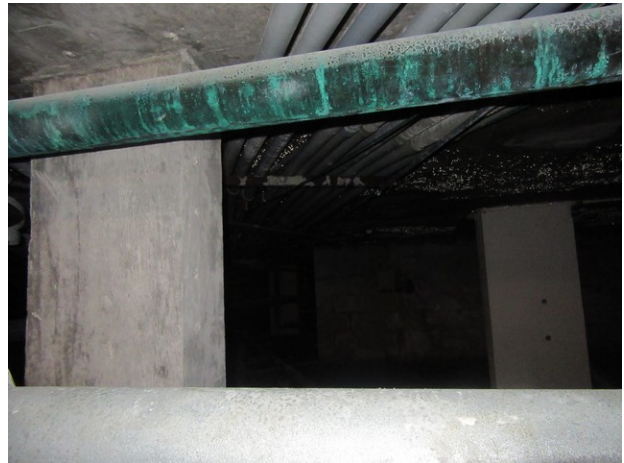
- Domestic Water, Supply and Return – Original and reported in satisfactory condition
- Sanitary Waste Disposal and Vent – Replaced in 2010 and reported in satisfactory condition

**Domestic water pipes**

**Domestic water pipe**

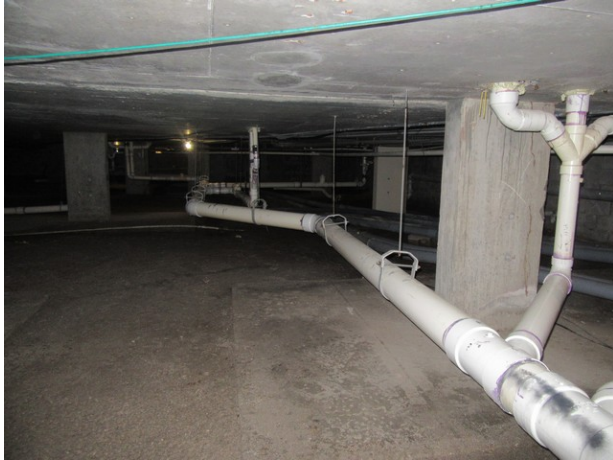
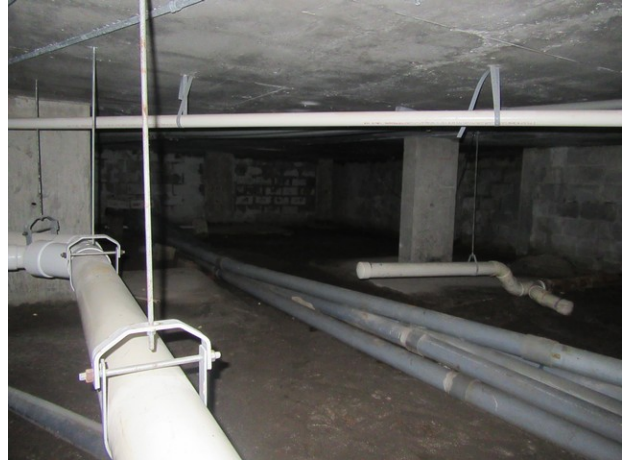
Sanitary waste pipes (Replaced in 2010)

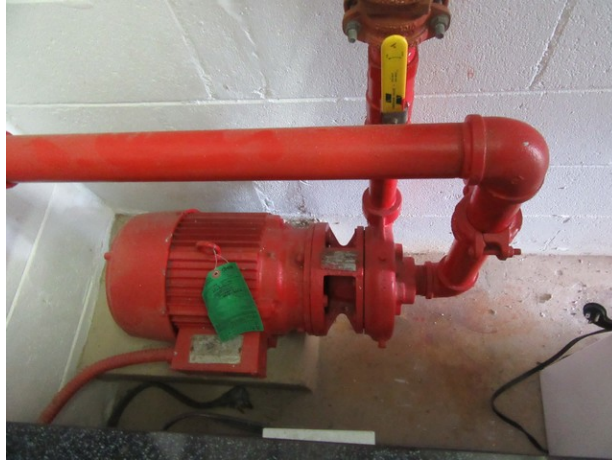
**Condition:** Reported satisfactory without operational deficiencies

**Fire suppression system pump**

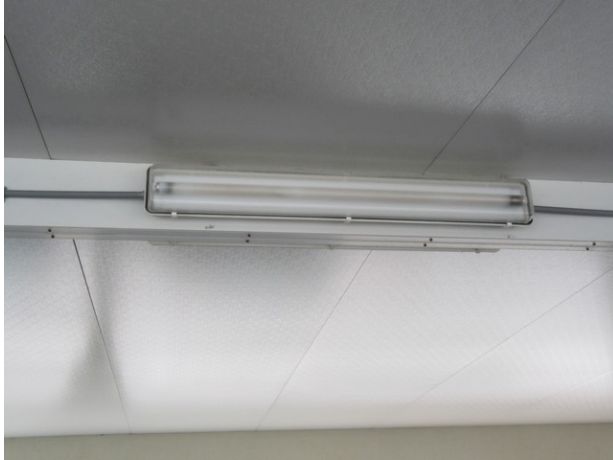
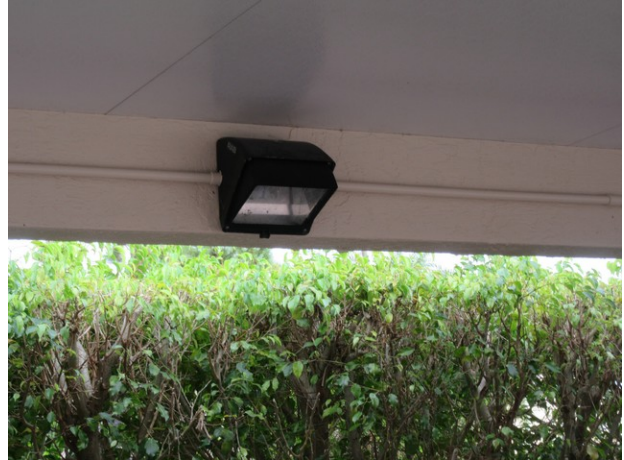
**Condition:** Satisfactory operational

**Carport light fixture**

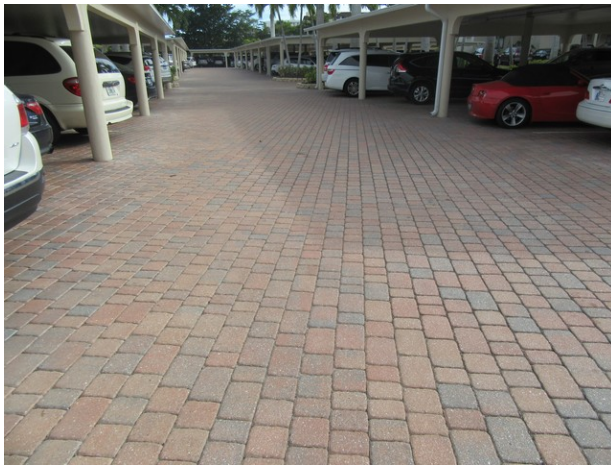
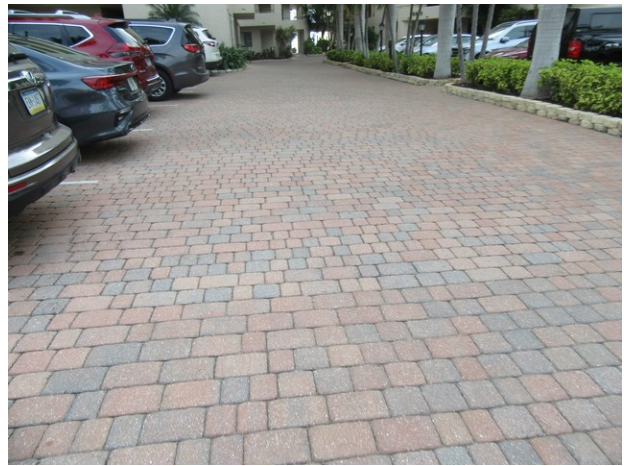
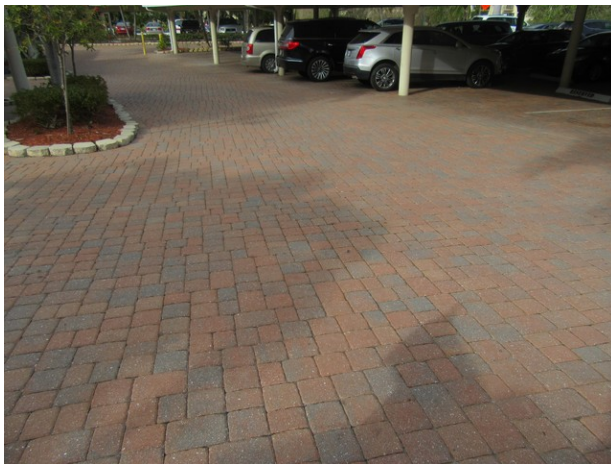
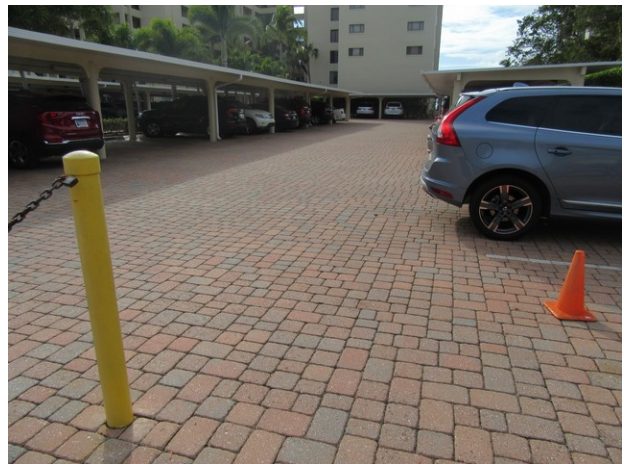
**Condition:** Good overall

Masonry paver driveway and parking areas

**Expenditure Detail Notes:** Expenditure timing and costs are depicted in the **Reserve Expenditures** table in Section 3. We suggest the Association conduct interim resetting and replacement of minor areas of pavers as normal maintenance, funded from the operating budget.

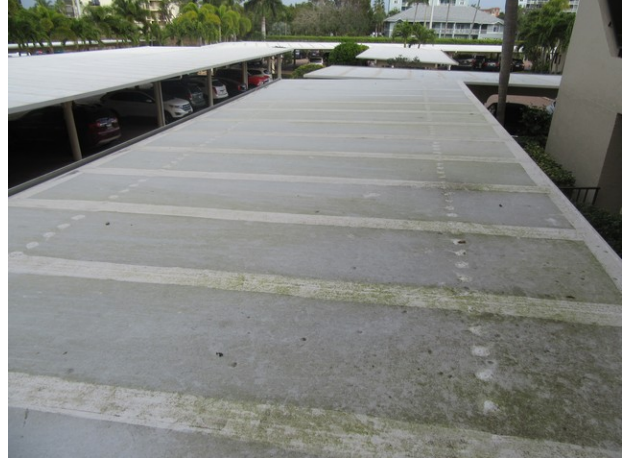
**Condition:** Good overall

**Carport thermoplastic roofs**

**Carport thermoplastic roof**

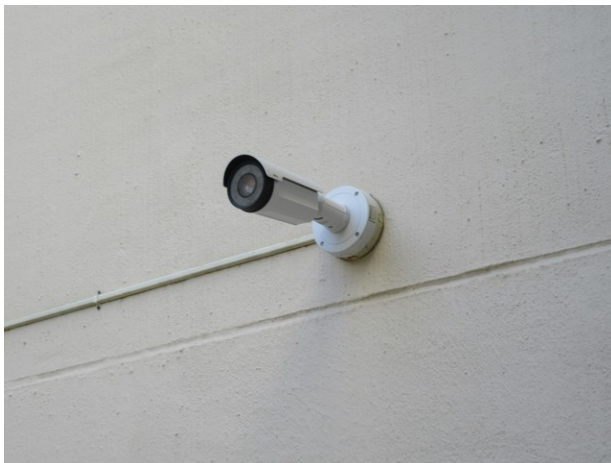
**Condition:** Reported satisfactory operational

Security system camera

Security system monitor

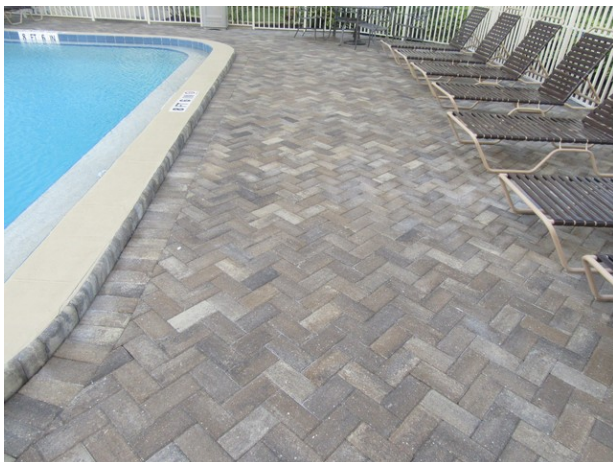
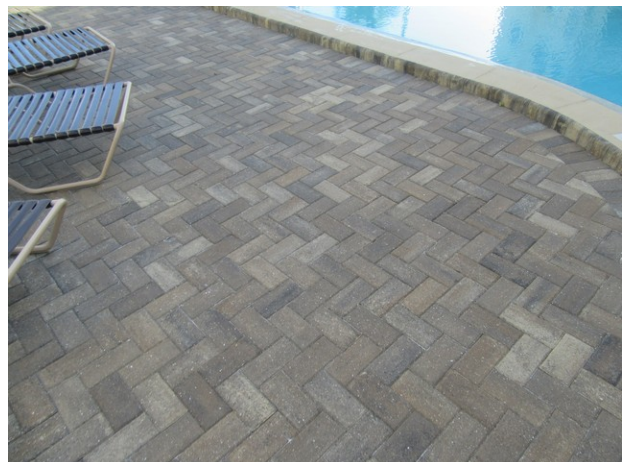
**Condition:** Good overall

**Masonry paver pool deck**

**Expenditure Detail Notes:** Expenditure timing and costs are depicted in the **Reserve Expenditures** table in Section 3. We recommend the Association fund interim inspections, partial replacements and repairs through the operating budget.

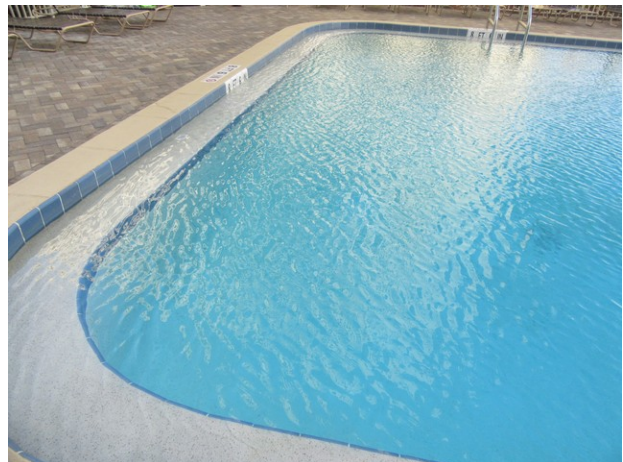
**Condition:** Good overall

**Pool plaster finish**

**Component Detail Notes:** Removal and replacement provides the opportunity to inspect the pool structure and to allow for partial repairs of the underlying concrete surfaces as needed. To maintain the integrity of the pool structure, we recommend the Association budget for the following:

- Removal and replacement of the plaster finish
- Partial replacements of the scuppers and coping as needed
- Replacement of tiles as needed
- Replacement of joint sealants as needed
- Concrete structure repairs as needed
