# FULL RESERVE STUDY

## The Sandarac Association, Inc.

**Fort Myers Beach, Florida**  
**February 11, 2019**

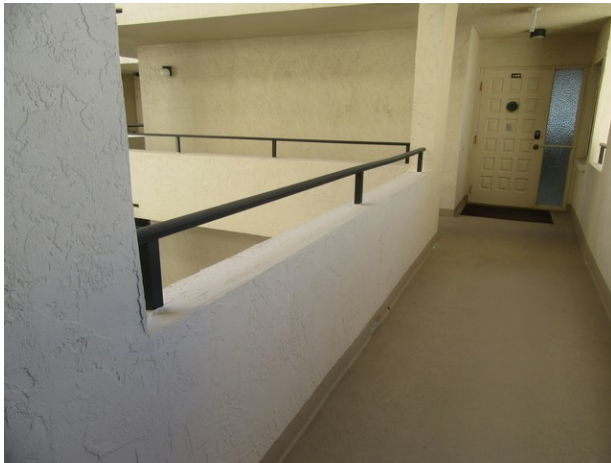
**Condition:** Good overall

**Breezeway railings**

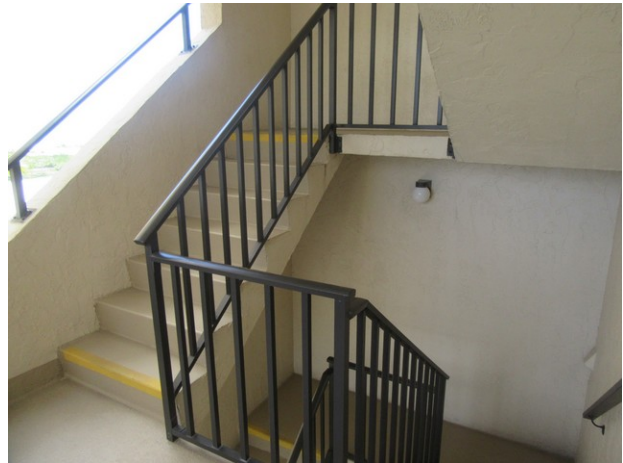
**Staircase railings**

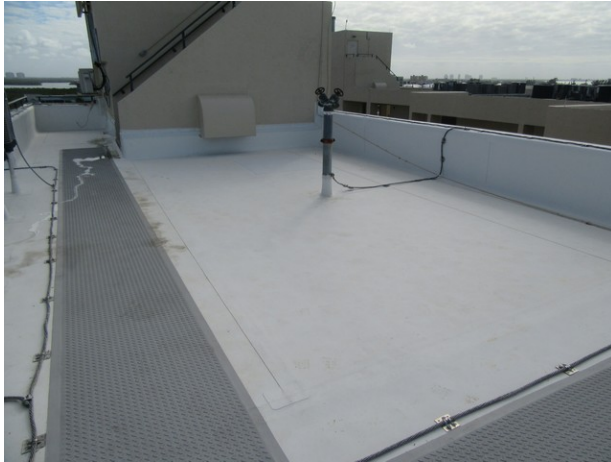
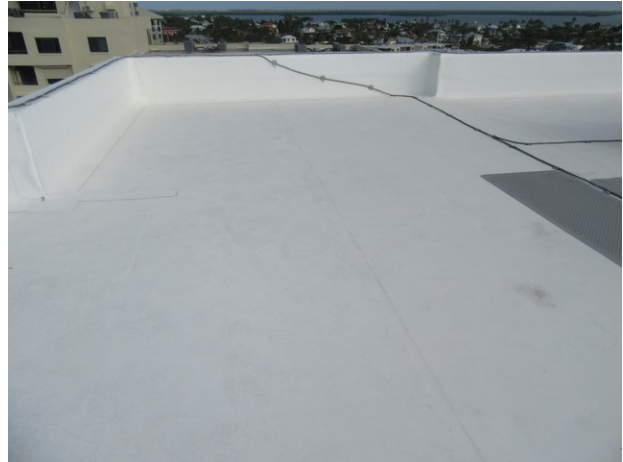
**Condition:** Good overall

**Thermoplastic roof**

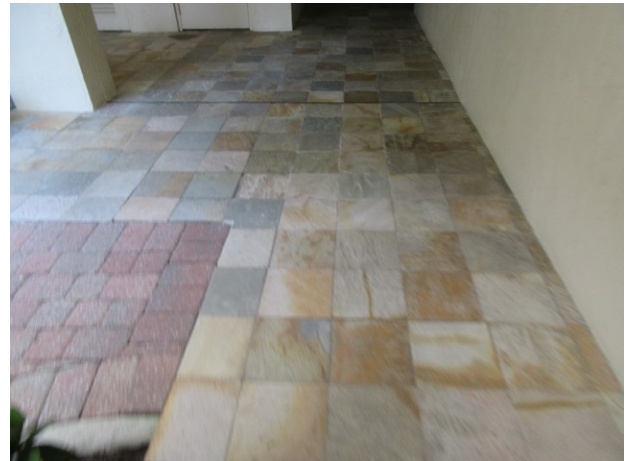
**Condition:** Good overall

**Tile floor coverings at 1<sup>st</sup> floor breezeway**

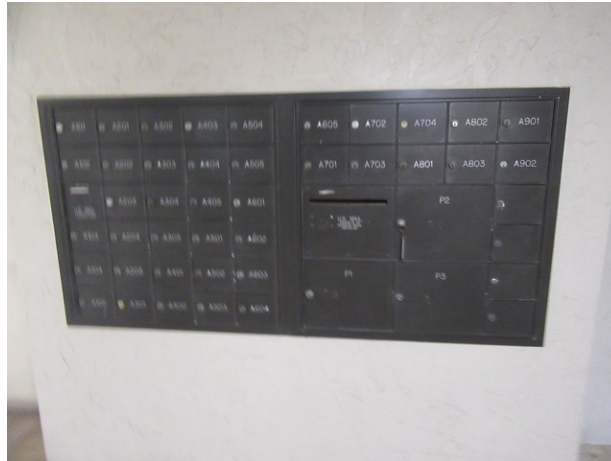
**Condition:** Reported satisfactory overall

Typical unit mailboxes

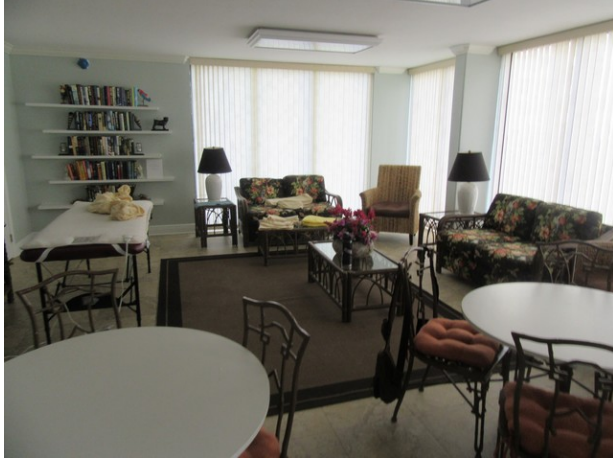
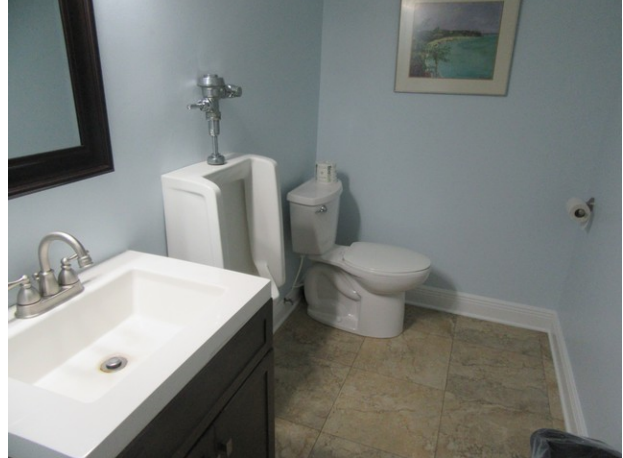
**Condition:** Good overall

**Social room overview**

**Social room rest room**

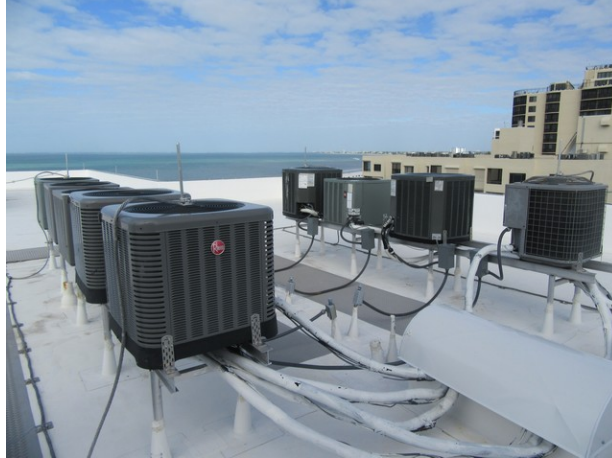
**Condition:** Reported satisfactory without operational deficiencies

### **Air condensing units**

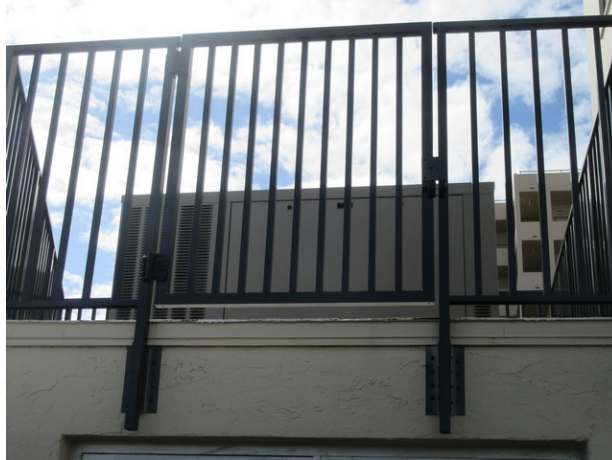
**Condition:** Reported satisfactory without operational deficiencies

**Generator**

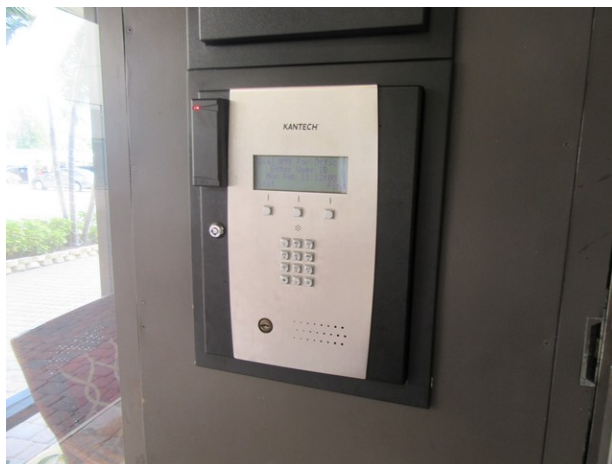
**Condition:** Reported satisfactory operational

**Intercom panel**

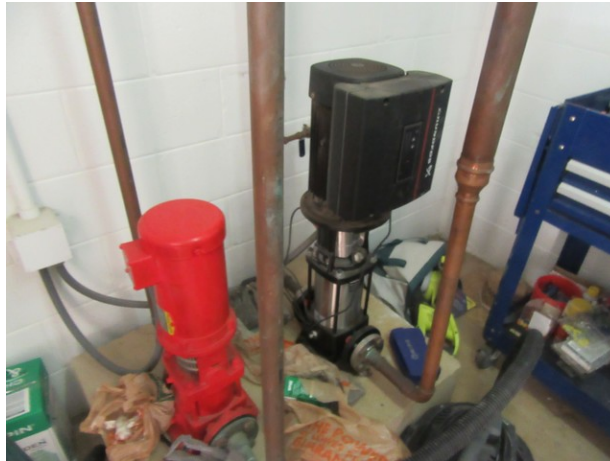
**Condition:** Reported satisfactory without operational deficiencies

**Domestic water pump**

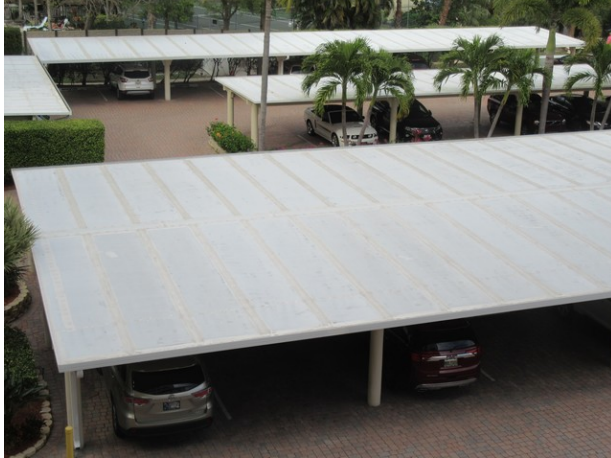
**Condition:** Good overall

**Carport thermoplastic roofs**

**Carport thermoplastic roof**

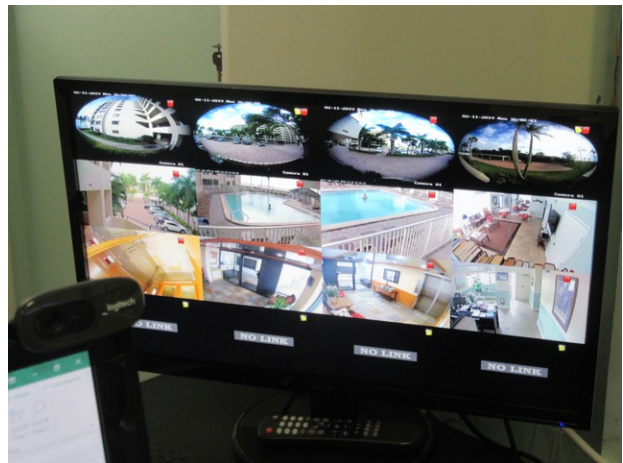
**Condition:** Reported satisfactory operational

Security system camera

Security system monitor

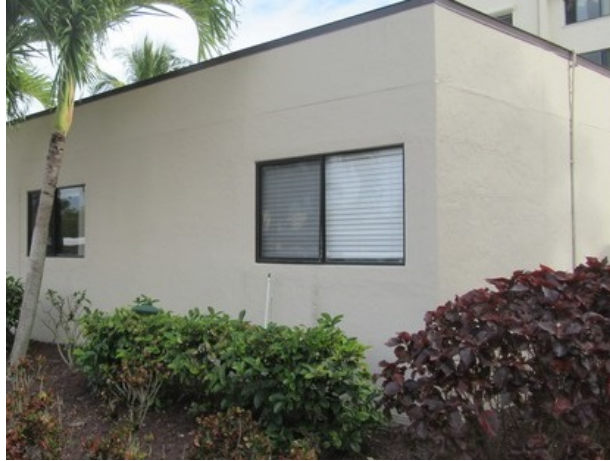
**Condition:** Good to fair overall

**Office window**

**Expenditure Detail Notes:** Expenditure timing and costs are depicted in the **Reserve Expenditures** table in Section 3. The estimate of cost is based on replacement with hurricane impact rated windows and doors.

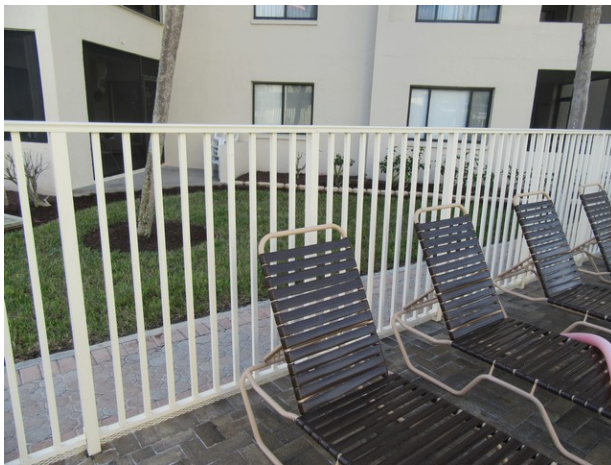
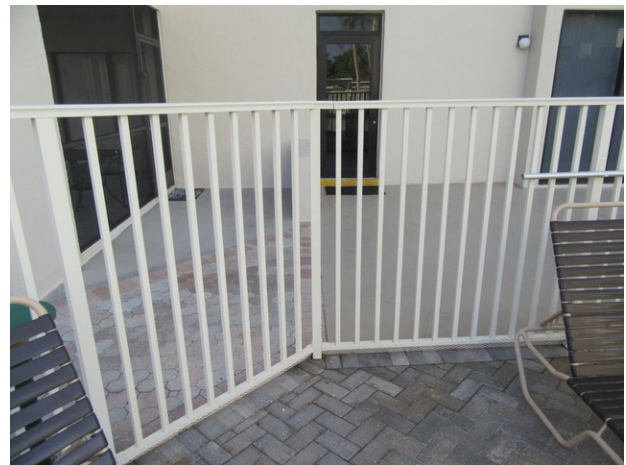
**Condition:** Good overall

Aluminum pool fence

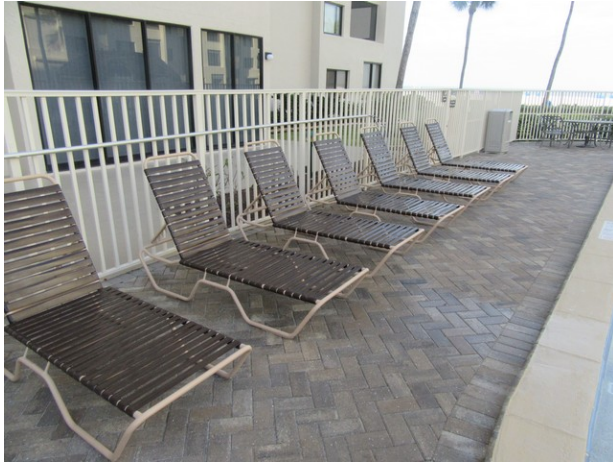
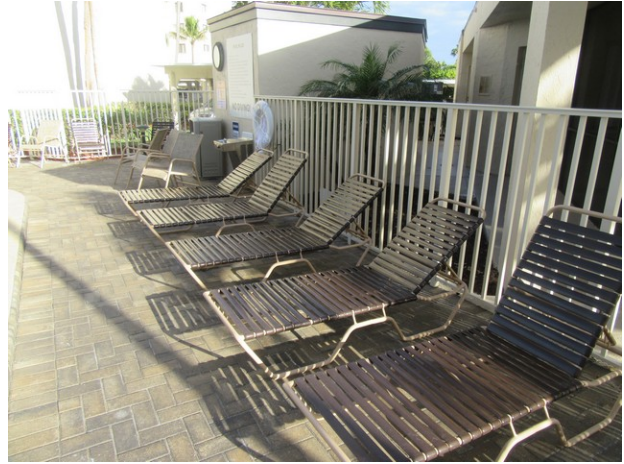
**Condition:** Good overall

**Pool furniture**

**Expenditure Detail Notes:** Expenditure timing and costs are depicted in the **Reserve Expenditures** table in Section 3. We recommend interim re-strapping, refinishing, cushion replacements, reupholstering and other repairs to the furniture as normal maintenance to maximize its useful life.

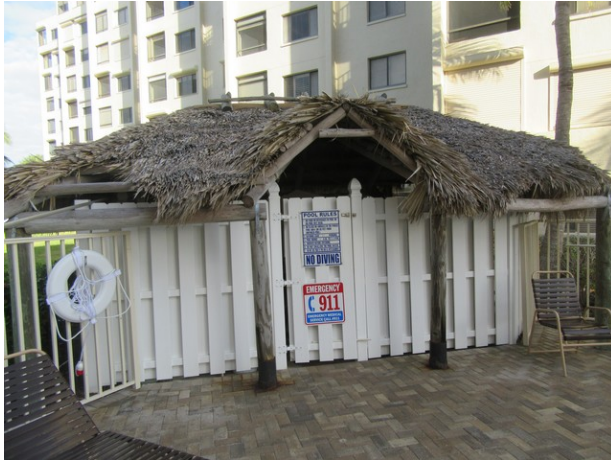
**Condition:** Fair overall

**Tiki hut overview**

**Expenditure Detail Notes:** Expenditure timing and costs are depicted in the **Reserve Expenditures** table in Section 3. At the request of Management, we include an allowance of \$40,000 in 2020 for complete replacement of the tiki hut. Future updates to the reserve study will incorporate costs associated with the new structure built in its place.
